REDFISH INSPECTIONS LLC

# PROPERTY INSPECTION REPORT FORM

2116 Gilbert Rd, Dickinson, TX 77539

06/13/2024 12:00 pm

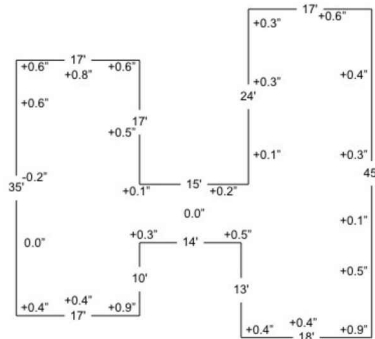
Garage

Foundation is approaching limits (deflection from middle is  $> .7$  and less than 1.5 inches and deflect is no more than 1 inch over 30 feet or 1 1/2 inches from side to side. Recommend to monitor

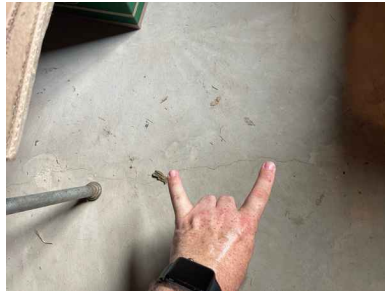
Example

Hairline cracks were noted on the foundation. Cracking in post tensioned slabs prior to tensioning the strands/tendons is very common and this situation has a specific name called “Restrained to Shortening” or RTS cracks. As concrete shrinks during the drying process it would not crack if it were supported by a perfectly smooth frictionless surface, but in reality this is not the case. The ground surface the slab is poured on will restrain the concrete from sliding, which develops stresses in the concrete causing cracks to develop, i.e. RTS cracking. If reinforcing steel or wire mesh were added near the surface ( 1.5” to 2” below the top) it would strengthen the concrete and help resist the dry shrinkage forces that develop, however most post tensioned residential slabs typically do not have any reinforcement other than the post tension cables, which are not designed for dry shrinkage. The good news is these RTS cracks are typically harmless and may partially close up if not too much debris has fallen in these cracks before the cables are tensioned.

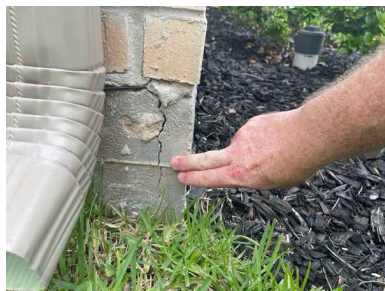
Example Front Left

Corner cracks were noted on one or more corners of the foundation. Corner cracks are generally caused by the early removal of form boards and/or improper flashing installation between the slab and the brick veneer/stone veneer. No structural defect was noted with this condition. We recommend having these cracks patched/sealed to minimize the opportunity of insect infestation.

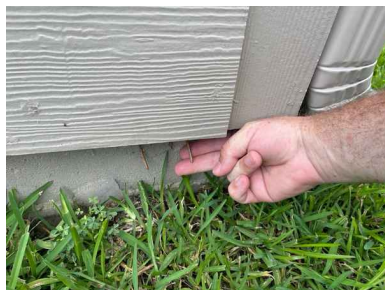
Example Garage Rear

Nails used to secure the post tension cables during pouring of the foundation were found protruding from the side of the slab. We recommend having these cut flush to the surface of the slab to prevent accidental injury.

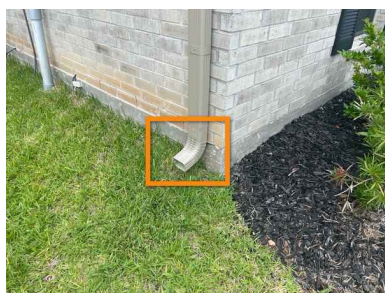
Example Front Left

One or more downspouts were discharging too close to the foundation. We recommend having downspouts discharge water at least five (5) feet from the structure. Storm water should be encouraged to flow away from the building at the point of discharge.

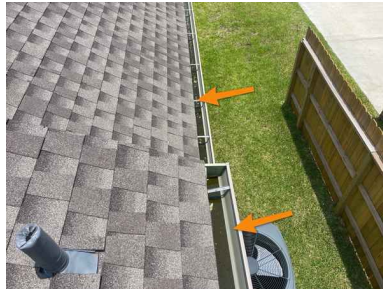
Example Left

One or more gutters did not appear to have sufficient slope to drain properly. The slope should be adjusted to avoid spilling roof runoff around the building – a potential source of water entry or water damage.

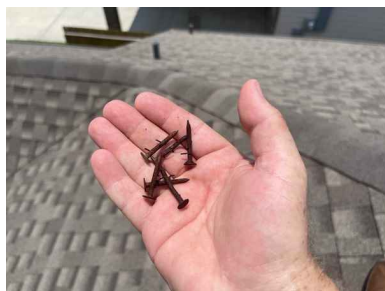
Loose nails were noted on the roof and should be removed. As the sun heats the roof material, the nail heads will sink into the roof covering which will leave indentations. Some nails may already be imbedded. We recommend cleaning to prevent damaging the roofing. All resulting holes and indentations from removed nails should be sealed.

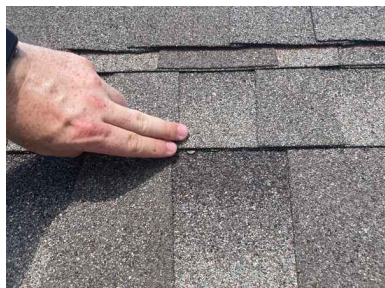
Example Front at ridge

A nail was found to be improperly placed as it was not covered by the upper row of shingles. The exposed nail could allow for water intrusion but also reduce the shingle's resistance to uplift as it was not placed in the reinforced section of the shingles. We recommend repair.

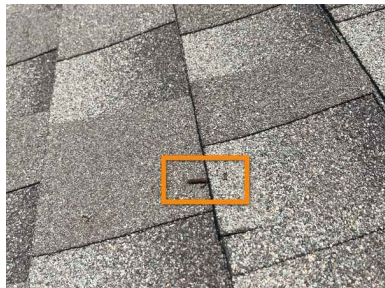
Example Left

Damaged, torn and/or missing shingles were observed on the roof. We recommend having all damaged shingles replaced to prevent further damage and water intrusion.

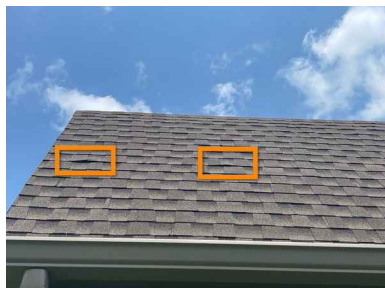
Example Garage Left

Uplifted shingles were observed. We recommend having the fastener (nail) resecured and the shingles sealed down to prevent further uplift and potential damage.

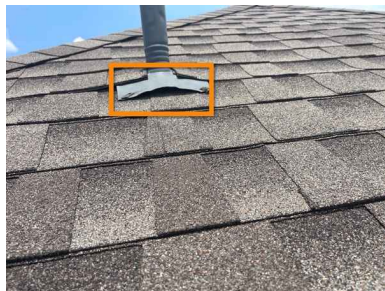
Example Left

Loose or uplifted flashing was noted on the roof. We recommend having this secured to avoid water intrusion.

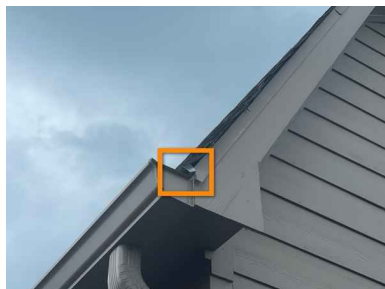
Example Garage Right Rear

Drip edge flashing was loose, uplifted, and/or damaged at the roof eaves. We recommend having this detail repaired to prevent damage to the fascia board and structure.

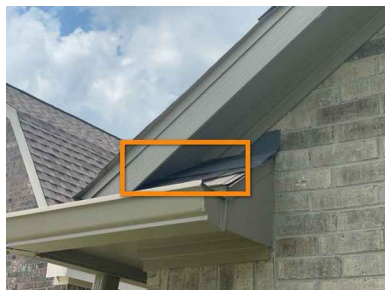
Example Front

A gap/penetration point was observed between the roof shingles and the soffit. We recommend having this patched/blocked to prevent intrusion into the attic space.

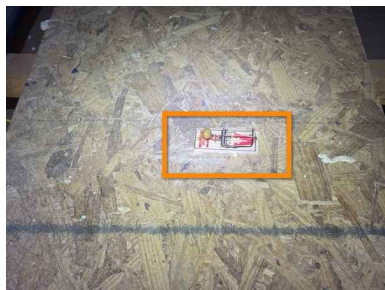
There was evidence of past vermin activity. A pest control specialist should be consulted in this regard. Vermin and other pests are part of the natural habitat, but they often invade homes. Rats and mice have collapsible rib cages and can squeeze through even the tiniest crevices. And it is not uncommon for them to establish colonies within crawlspaces, attics, closets, and even the space inside walls, where they can breed and become a health-hazard. Therefore, it would be prudent to have an exterminator evaluate the residence to ensure that it is rodent-proof, and to periodically monitor those areas that are not readily accessible.

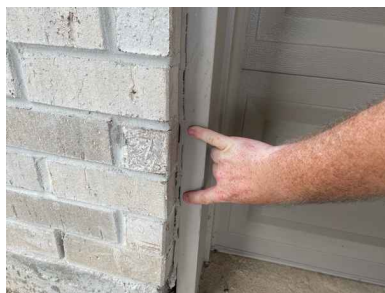
Example Garage Front

The exterior caulking in multiple areas around the house at various siding transitions, expansion joints, wall protrusions, doors, windows and other areas, was deteriorated or insufficient. Exterior caulking is the first energy efficient measure to install. This helps minimize air flow and moisture through cracks, seams, utility penetrations and openings. Controlling air infiltration is one of the most cost effective measure in modern construction practice. Good caulking and sealing will reduce dust, dirt, and prevent damage to structural elements. We recommend updating regularly.

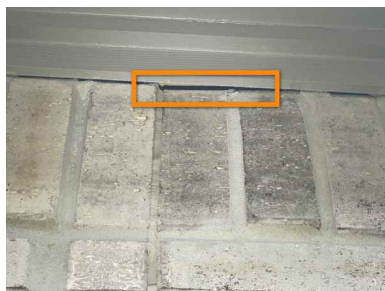
Example Left

A hole was observed in an exterior wall. We recommend having this patched/sealed to prevent pest intrusion.

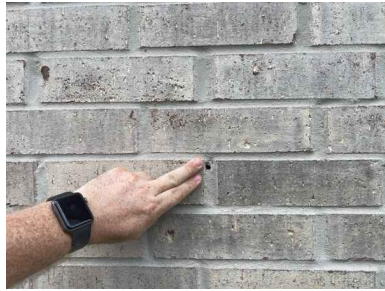
Example Left

The mortar at the exterior brick/stone veneer was cracked and/or deteriorated. We recommend having these areas repointed to prevent excess moisture intrusion.

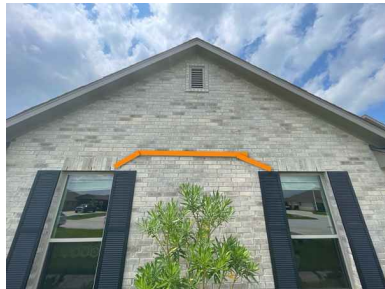
Example Front

A step crack was observed on the exterior brick veneer. This typically is an indication of structural movement. We recommend patching and monitoring.

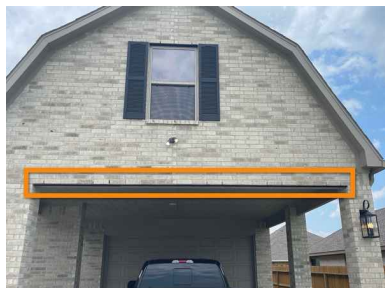
Example

It has become rather common to see two-car garage doorways formed with a single opening that is 16- to 18-foot wide. Unfortunately, the brick veneer over these openings is usually supported by a typical 4x4 steel angle even though there is no rolled steel angle-shape made that can span 16 feet and support more than 3 feet brick height. A typical 4-inch steel angle is inadequate for any amount of brick when opening width is more than about 12 feet. Often an inadequately sized steel lintel leads to long-term sagging of the doorway and subsequent cracking of the brick veneer. A specially engineered repair can be implemented to correct these problems utilizing through-bolts into the existing framing headers and/or installation of steel support beams.

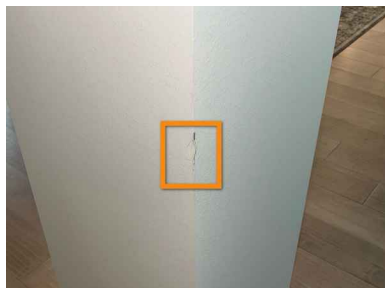
Example entry hall

General damage was noted at the Sheetrock/Drywall. We recommend to repair as needed.

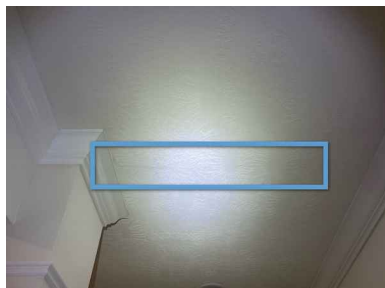
Example entry

Evidence of patching was detected, which indicates previous work performed. We recommend asking the sellers about the history of any prior problems and monitoring the area for future issues.

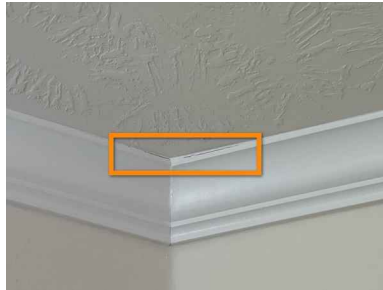
Example Living Room

Separation was observed at the crown molding and/or baseboards in various areas throughout the structure. This could be indicative of structural/foundation movement or may be the result of regular settlement or improper installation. We recommend having these areas sealed and monitoring for additional signs of movement.

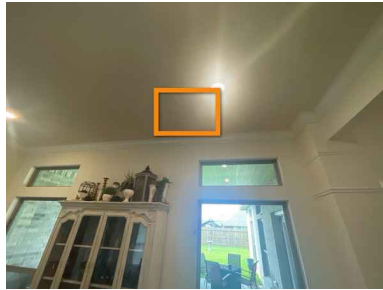
Dining Room location detail

A thermal anomaly was observed with an infrared thermal imager. The area was confirmed with a moisture meter to have elevated moisture. We recommend repairs to the problem moisture source.

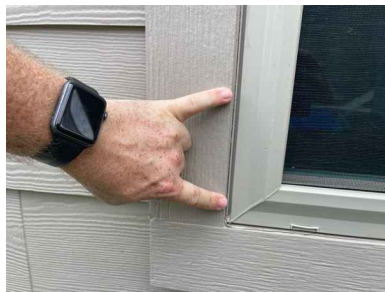
Example Garage Left

The exterior and interior caulk around the windows was deteriorated and/or insufficient. We recommend repair. Exterior caulking is the first energy efficient measure to install. The purpose of exterior caulking is to minimize air flow and moisture through cracks, seams, utility penetrations and openings. Controlling air infiltration is one of the most cost effective measures in modern construction practices, a home that is not sealed will be uncomfortable due to drafts and will use about 30% more heating and cooling energy than a relatively air-tight home. In addition, good caulking and sealing will reduce dust and dirt in the home and prevent damage to structural elements.

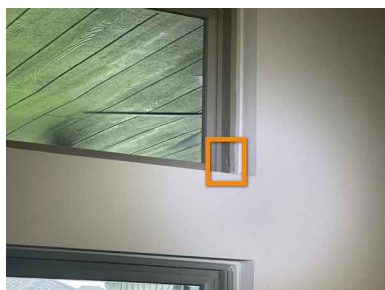
Example Dining Room

Damaged window trim was noted. We recommend repair/replacement.

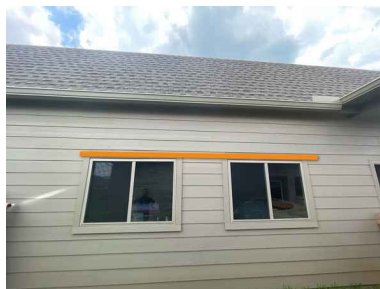
Example Garage Left

The flashing over a window was not visible. This might require annual evaluation and repair to the caulk to prevent water intrusion into the structure.

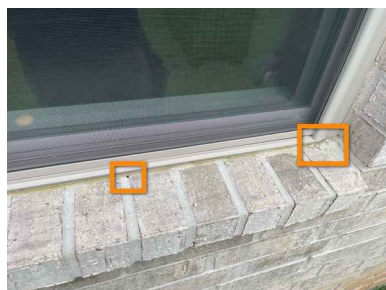
Example Rear

Deteriorated mortar was observed at one or more window ledge(s) at the time of inspection. We recommend having mortar sealed or repointed to avoid moisture intrusion into the structure and help keep the bricks secure.

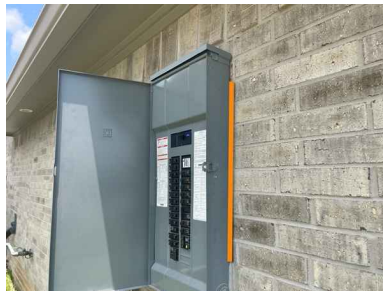
We recommend caulking the top and sides of exterior electrical panels to prevent moisture intrusion.

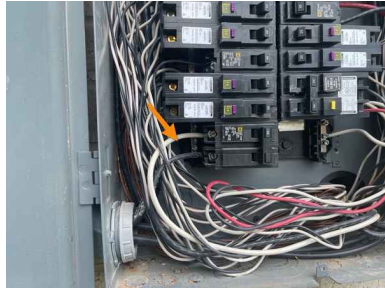
recommend having conductors appropriately marked. This can usually be accomplished with a piece of electrical tape or partially marking the wire with a marker.

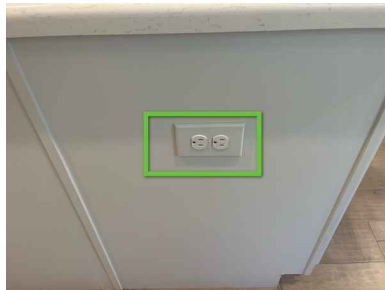
Outlet receptacles were present on the side of the kitchen island/peninsula. While installation of receptacles in these locations is not prohibited, since 2023, it has come to be considered a potential safety hazard by many experts as the cord for common cooking appliances could be pulled or snagged resulting in impact or burn injuries. Safer receptacle designs capable of being installed on the top surface are available by various manufacturers. Extra care should be taken when using these receptacles to prevent hazards, particularly if/when children are present.

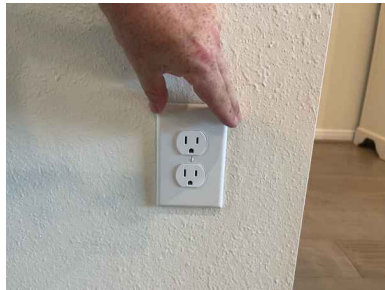
Example Dining Room

One or more outlets were improperly secured and moved when plugs were inserted. Outlets should be securely installed to prevent fire, shock and/or electrocution hazard. We recommend having these improved.

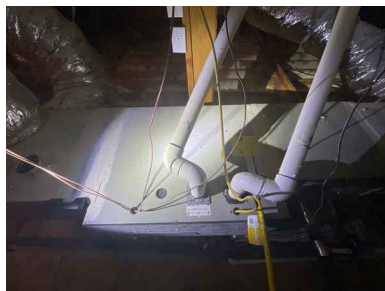
**Evaporator Coils Sealed:** The evaporating coils had been sealed. Cutting the seal goes beyond the scope of the home inspection. We were unable to view the condition of the coils. We recommend having the HVAC system serviced on at least a biannual basis.

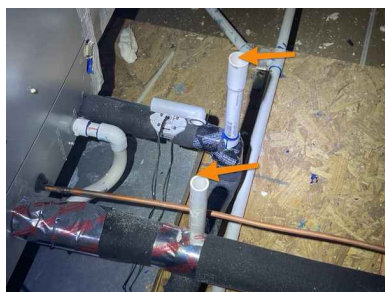
The primary condensate drain line cleanout did not have cap. We recommend adding one to prevent debris from clogging the line.

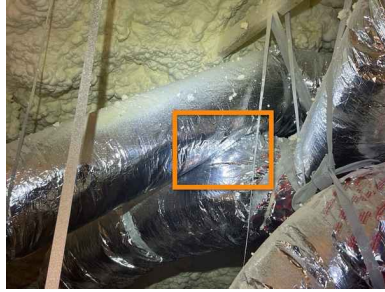
Example

Multiple air ducts were found to be in contact with one another. Today's standards do not allow this practice anymore as thermal bridging could create condensation inside or between the ductwork. We recommend having the ducts strapped and separated.

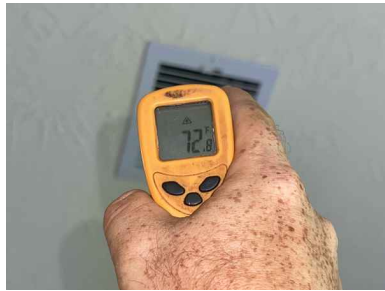
Example Primary Bedroom

A significant temperature discrepancy was measured at some registers compared to others in the structure. Should this affect your living comfort, we recommend having the duct further evaluated and adjusted as needed.

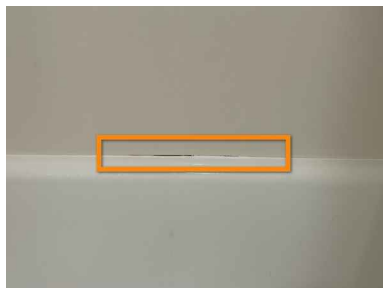
Example Guest Bathroom 1

Deteriorated caulking/grout was noted, which may allow damage from moisture intrusion of the wall assembly at a bathroom. We recommend having this recaulked.
