REDFISH INSPECTIONS LLC

# PROPERTY INSPECTION REPORT FORM

2116 Gilbert Rd, Dickinson, TX 77539

06/13/2024 12:00 pm

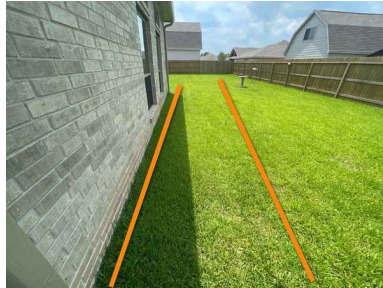
Example Rear

The grading around the structure should be improved to promote the flow of storm water away from the house. This can usually be accomplished by the addition/removal of top soil. The ground should slope away from the structure at a rate of six inches in the first ten feet. In some cases, the installation of an underground drain may be a more efficient or cost effective solution.

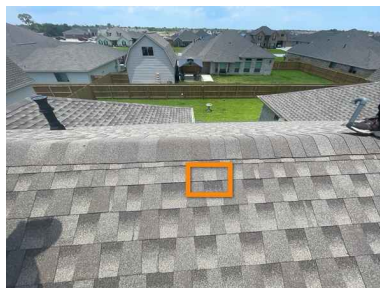
Improper nail location detail

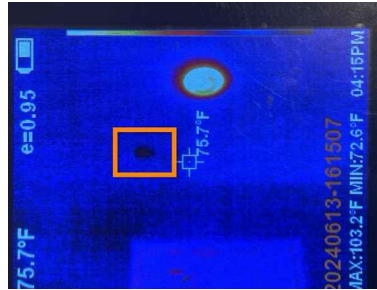
Dining Room thermal anomaly

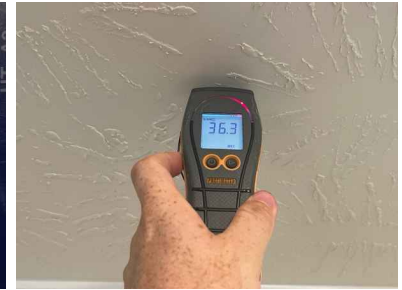
Dining Room confirmed wet

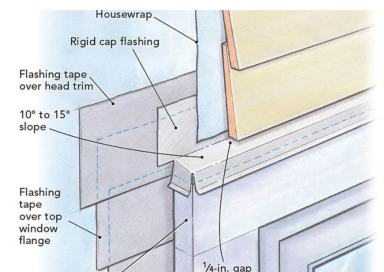
Example Garage Left

The flashing over a window was not visible. This might require annual evaluation and repair to the caulk to prevent water intrusion into the structure.

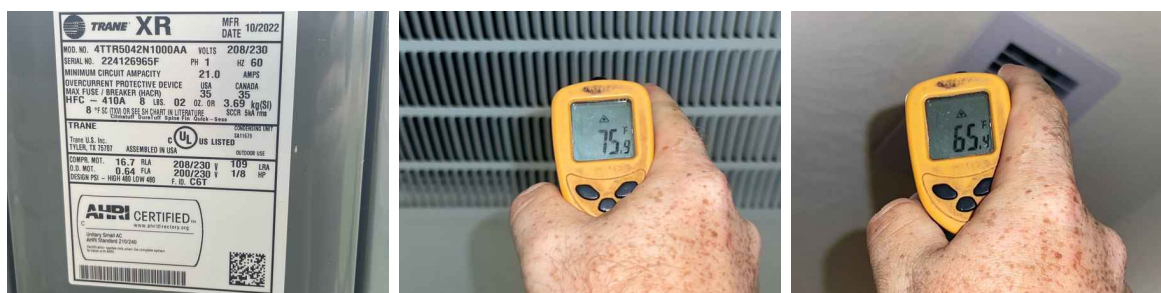
*Unit 1:* Photo of condenser data plate, Photo of return air temperature, Photo of vent temperature

Delta T Result: 10 Degrees F

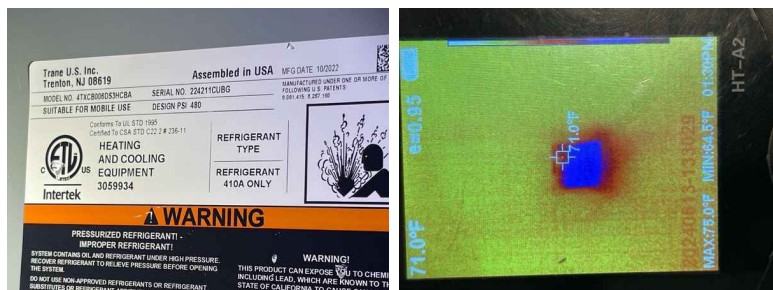
**Evaporator Coils Sealed:** The evaporating coils had been sealed. Cutting the seal goes beyond the scope of the home inspection. We were unable to view the condition of the coils. We recommend having the HVAC system serviced on at least a biannual basis.

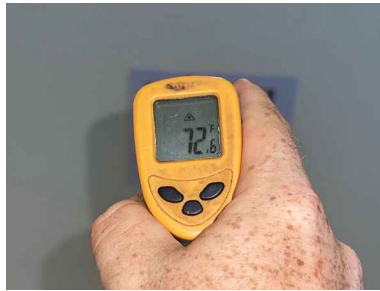
Example Primary Bathroom

A significant temperature discrepancy was measured at some registers compared to others in the structure. Should this affect your living comfort, we recommend having the duct further evaluated and adjusted as needed.

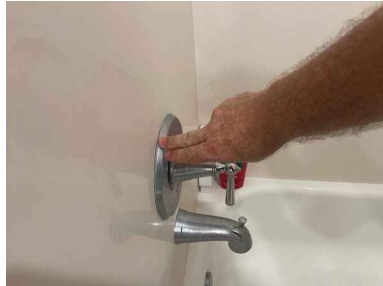
Example Guest Bathroom 1

## 3: Deteriorated Caulk / Grout

Deteriorated caulking/grout was noted, which may allow damage from moisture intrusion of the wall assembly at a bathroom. We recommend having this recaulked.

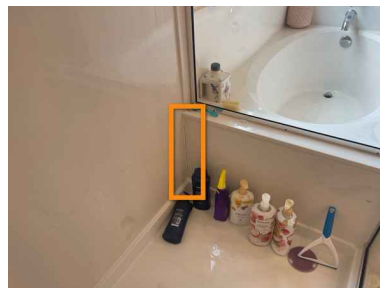
Example Primary Bathroom

## 4: Leak at Shower Head

We observed a leak at a shower head at the time of inspection. We recommend having this repaired.
